Re: Property Condition Assessment of Goodwill Skills Ken Weber Community Campus, 408 Ninth Street Southwest, Canton, Ohio 44707

PROPERTY CONDITION REPORT

Goodwill Skills Ken Weber Community Campus

408 Ninth Street Southwest, Canton, Ohio 44707

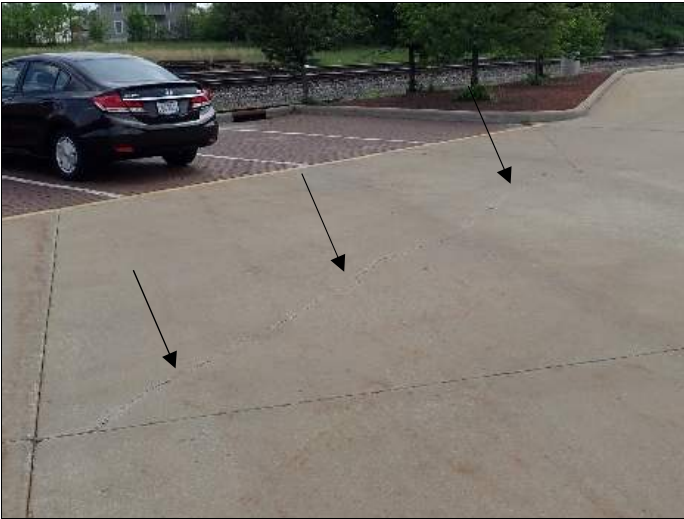
Minor shrinkage cracks in concrete drive surfaces were observed at a few locations in the publically accessible parking areas. Deterioration at the intersections of control joints were observed throughout the concrete surfaces by the rear loading docks, which is likely related to loads from heavy delivery and maintenance vehicles in this area. Sealing cracks and repairing deteriorated concrete is recommended.

Typical shrinkage crack in concrete

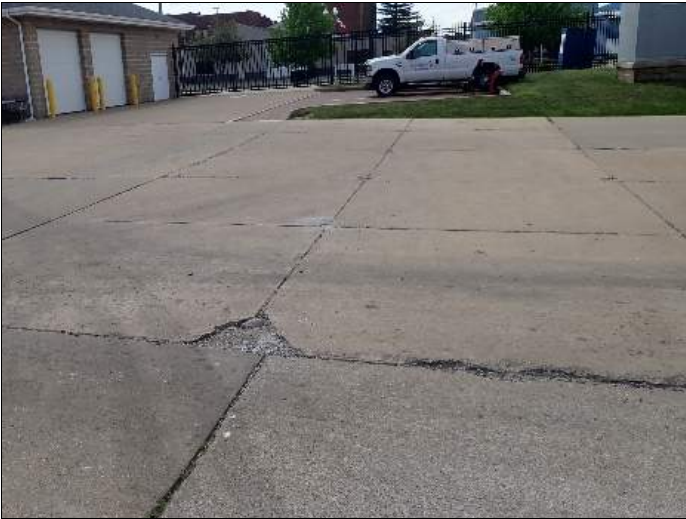
Typical deterioration of rear parking area concrete

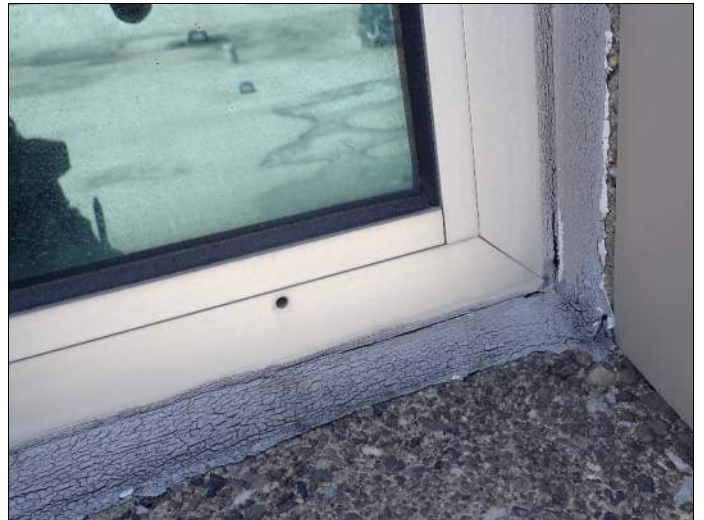
Sealant around windows and in construction joints between exterior precast concrete panels was generally cracked and deteriorated throughout the building envelope. It is recommended the old, deteriorated sealant be removed and replaced with new sealant.

Deteriorating window sealant

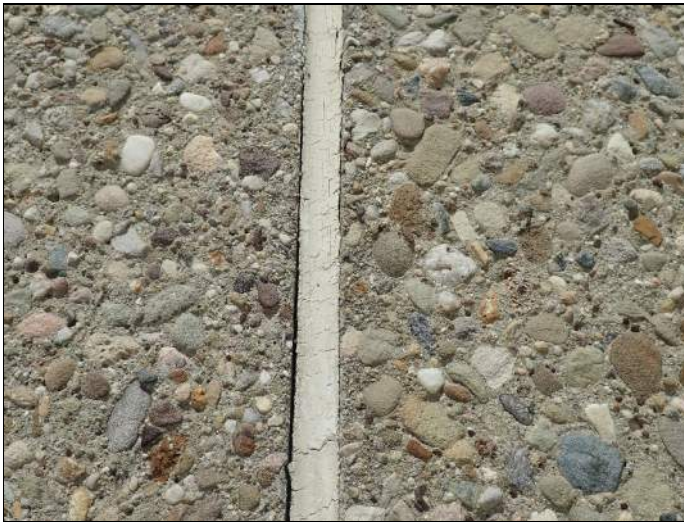
Deteriorating sealant at wall panel construction joint

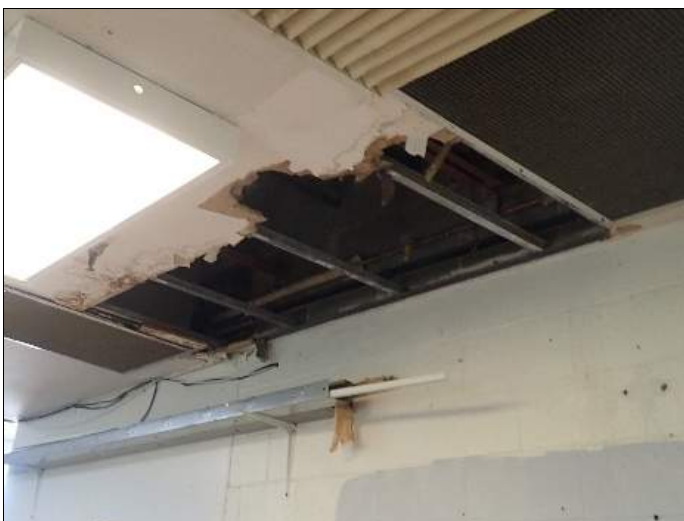
A small section of drywall ceiling in the maintenance room was missing/damaged. The cause of damage was reportedly from leaking pipes that was previously repaired. It is recommended that the ceiling be repaired.

Damaged ceiling drywall in maintenance room

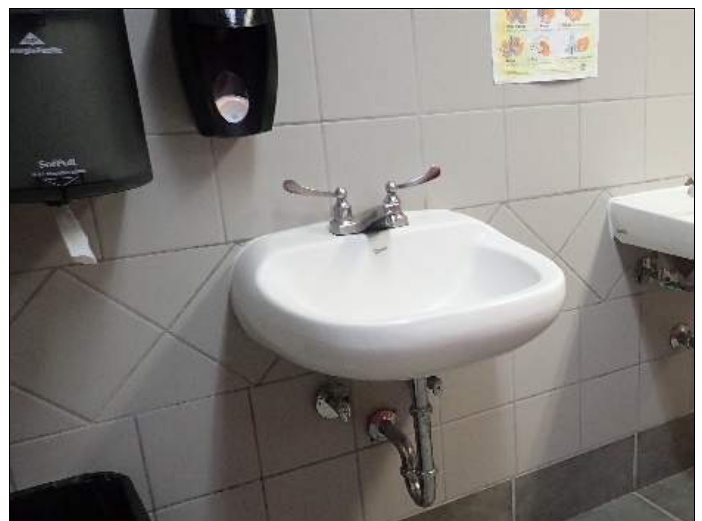
Lavatory without plumbing protection

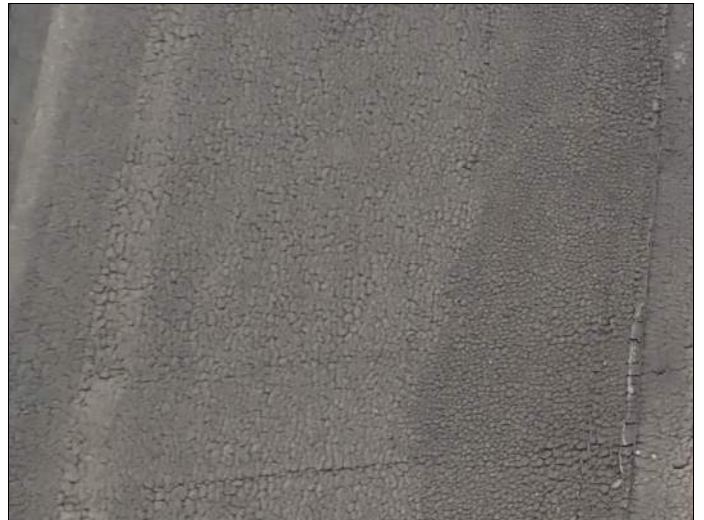
The entryway at the east side of the building has a low-slope roof covered in adhered roll roofing membrane. The roofing membrane exhibited extensive alligator cracking characteristic of advanced age-related deterioration.

The age of the roll roofing membrane on the side entrance roof could not be identified. However, based on its condition, it has exceeded its useful life, and replacing the roofing over the east entryway should be anticipated within the term.

Typical alligator cracking of roll roofing

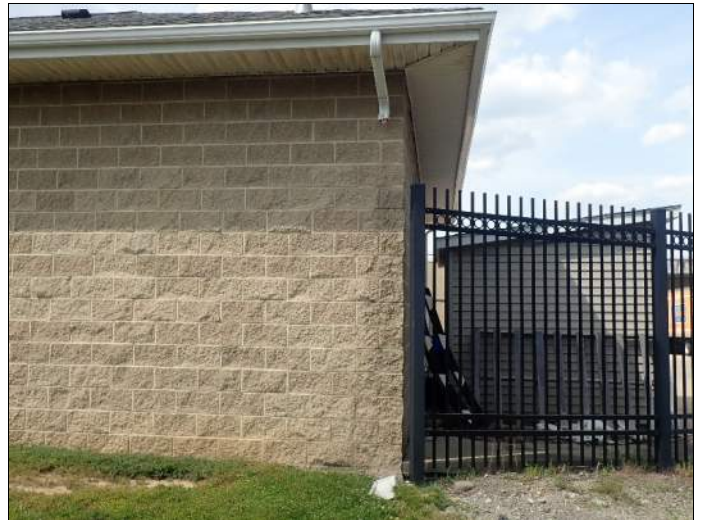
One of the garage downspouts was disconnected. Repairing this downspout is recommended.

Disconnected garage downspout

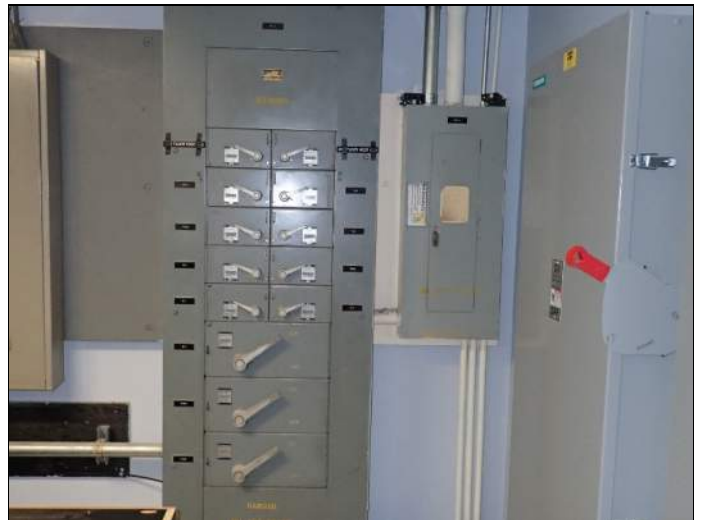
The age of the electrical distribution panel and subpanels could not be determined. Electrical distribution panels have an average useful life of 20 years. Several of the subpanels were rusting, indicating they are nearing the end of their useful life. Replacing the distribution panels within the term is recommended.

Typical subpanel
