Re: Property Condition Assessment of Goodwill Skills Ken Weber Community Campus, 408 Ninth Street Southwest, Canton, Ohio 44707

PROPERTY CONDITION REPORT

Goodwill Skills Ken Weber Community Campus

408 Ninth Street Southwest, Canton, Ohio 44707

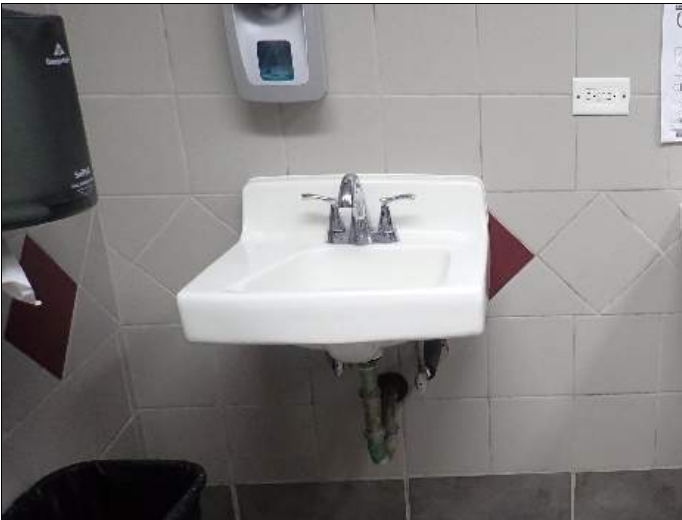
Lavatory without plumbing protection

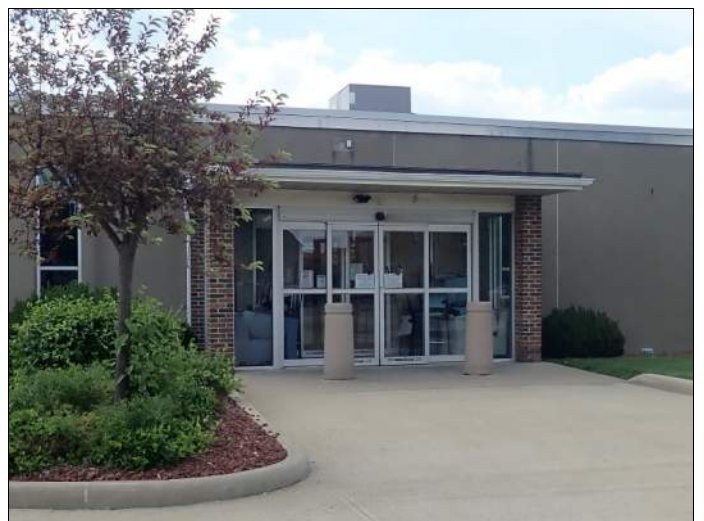
Overview of side entrance

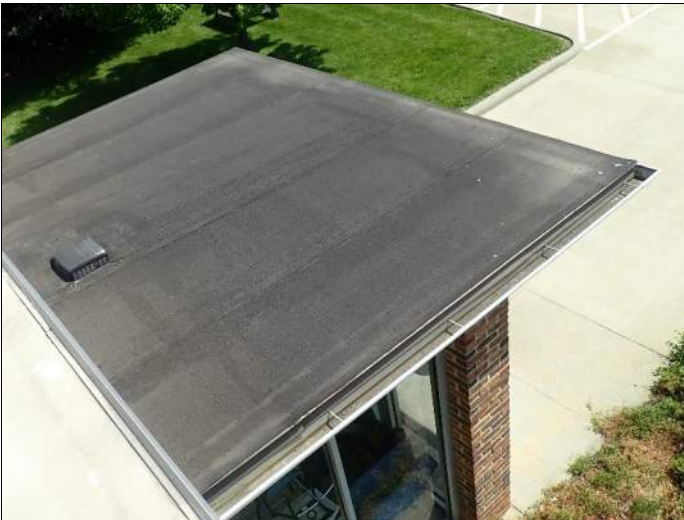
The entryway at the east side of the building has a low-slope roof covered in adhered roll roofing membrane. The roofing membrane exhibited extensive alligator cracking characteristic of advanced age-related deterioration.

Overview of side entrance roof

The age of the roll roofing membrane on the side entrance roof could not be identified. However, based on its condition, it has exceeded its useful life, and replacing the roofing over the east entryway should be anticipated within the term.

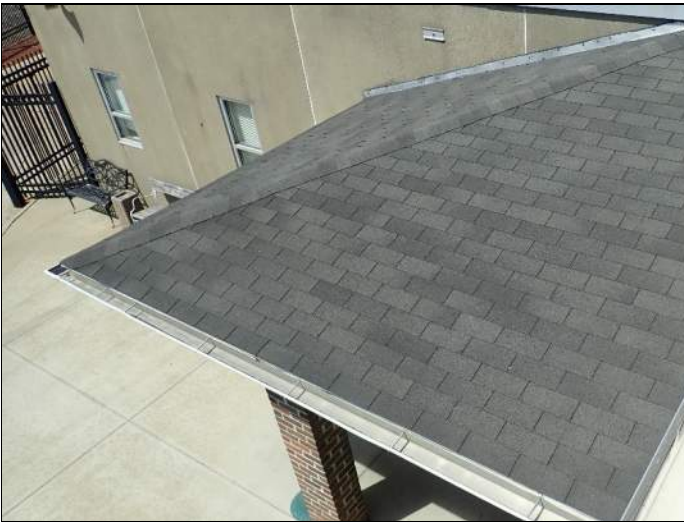
Overview of hip roof

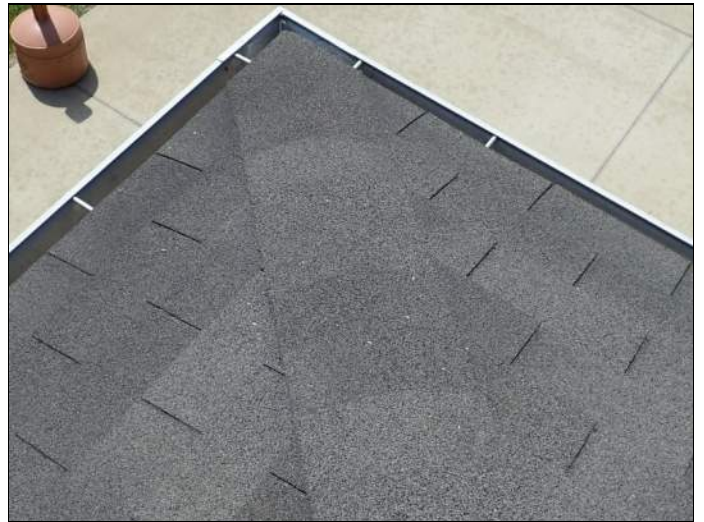
Typical shingles on hip roof

The age of the current shingles on the hip roof could not be identified. However, based on their condition, the shingles are approaching the end of their useful life, and their replacement should be anticipated within the term.

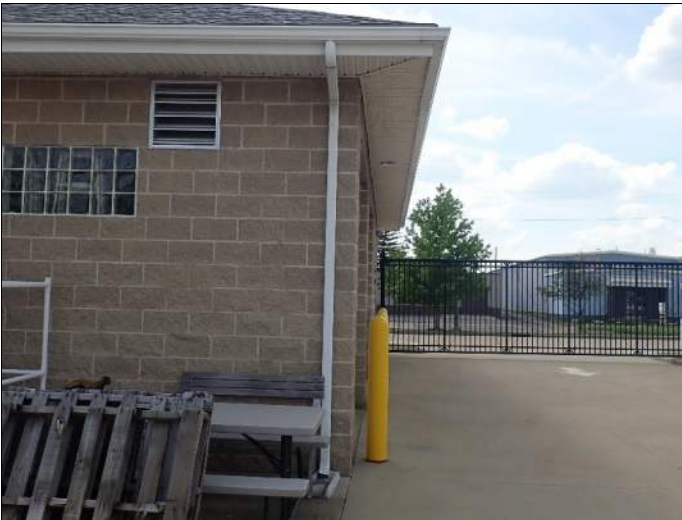
Typical garage gutter and downspout

One of the garage downspouts was disconnected. Repairing this downspout is recommended.

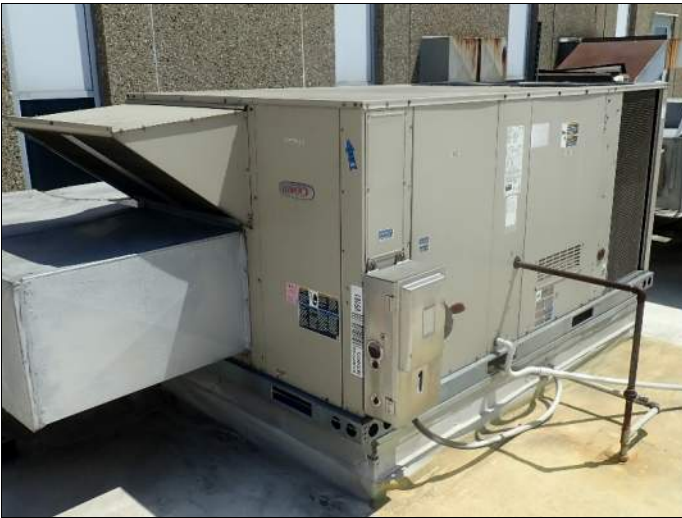
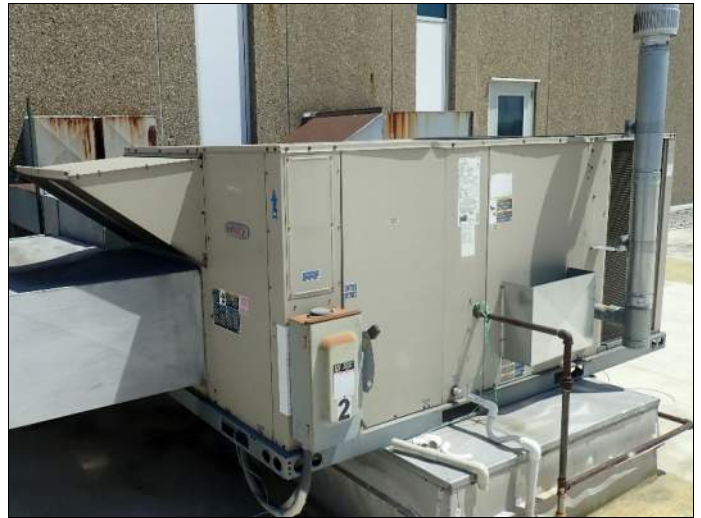
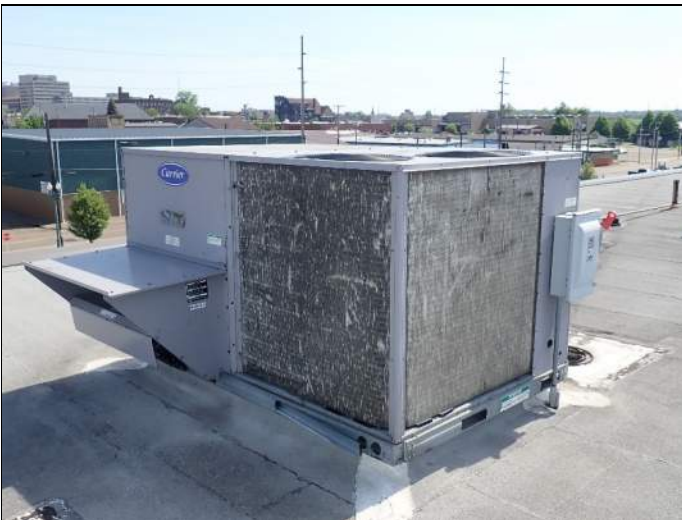
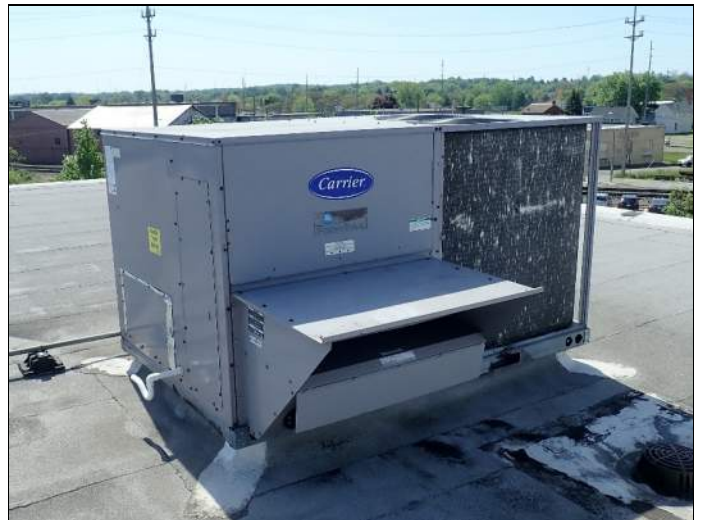
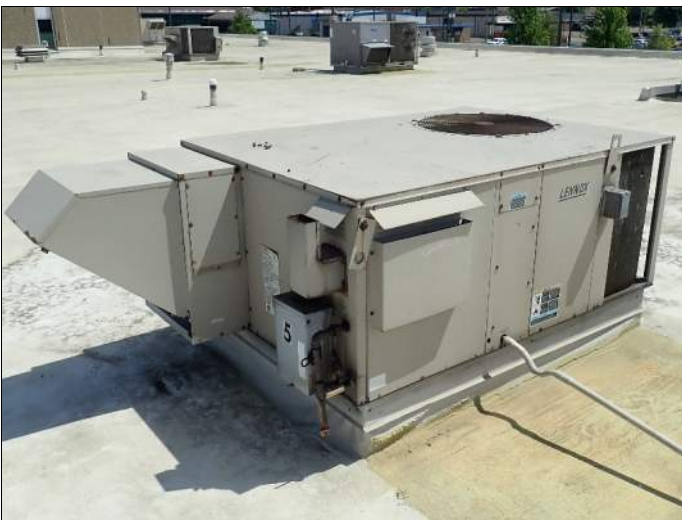
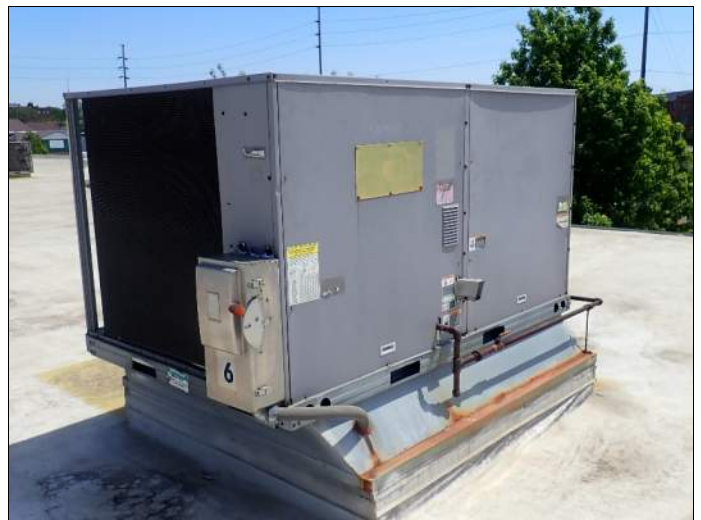
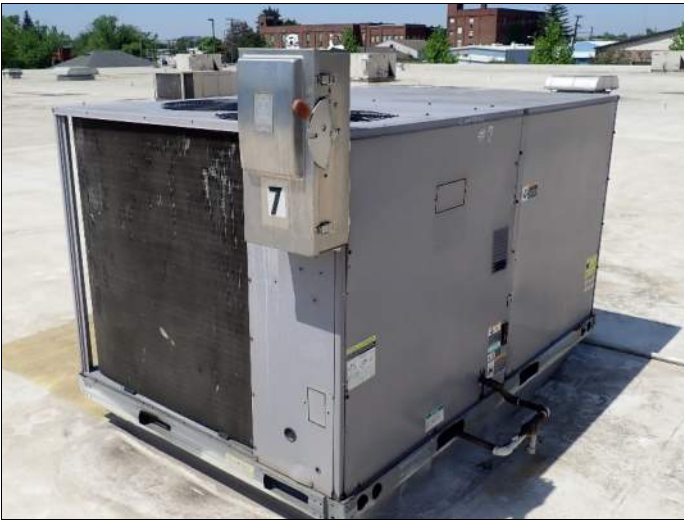
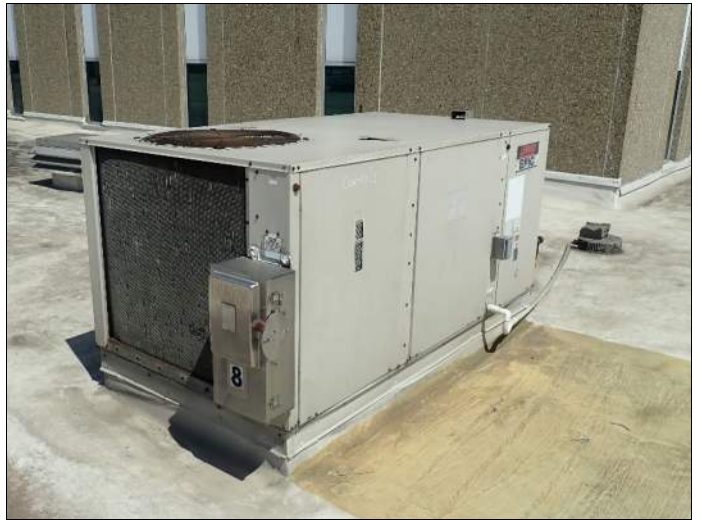
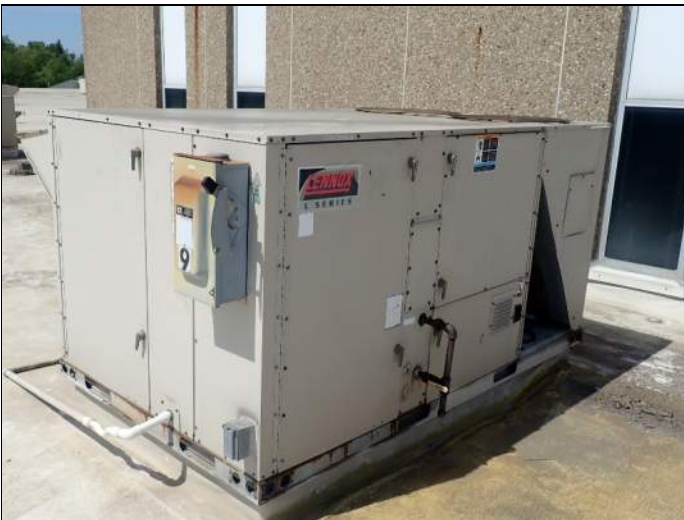
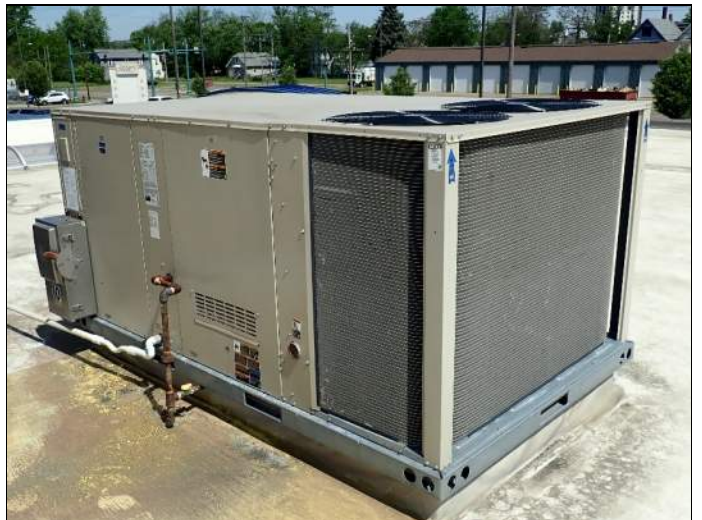
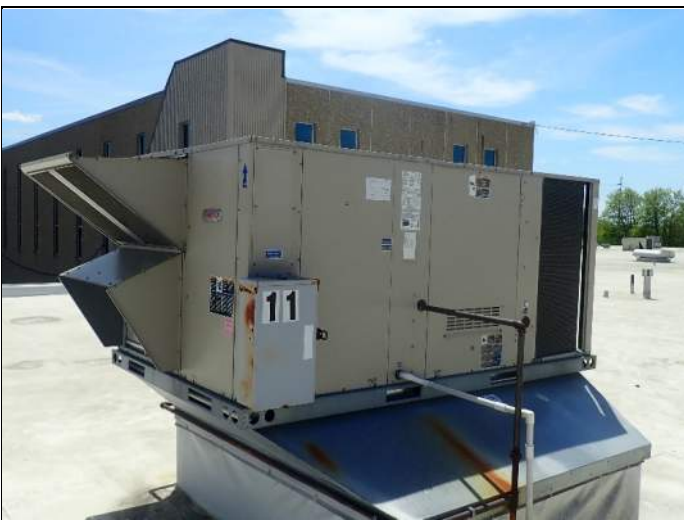
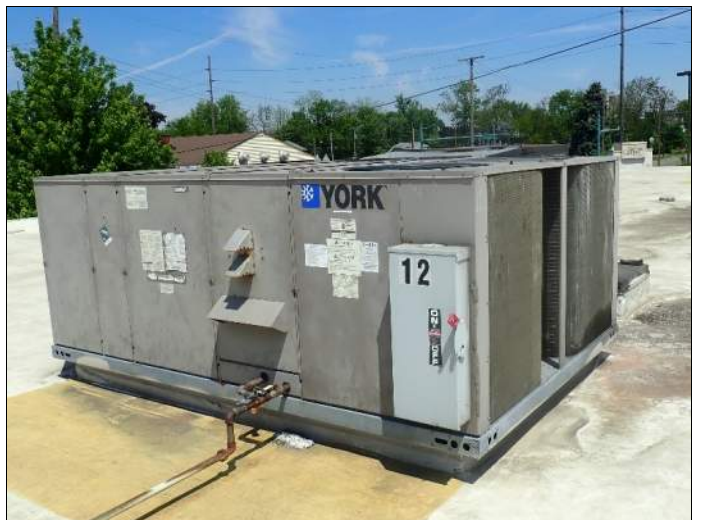
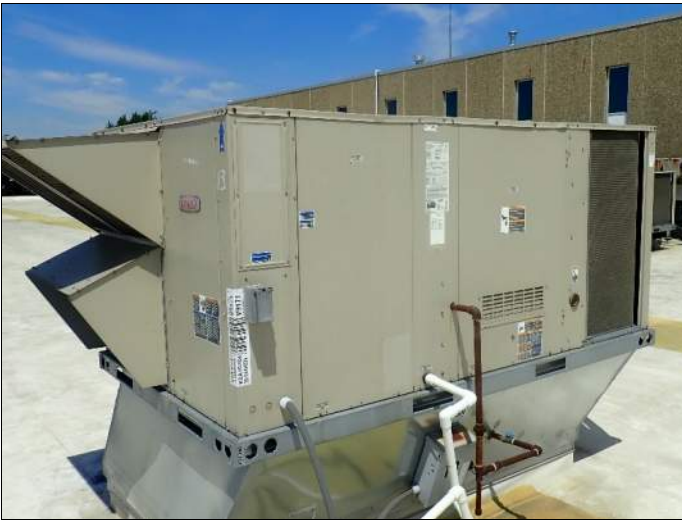
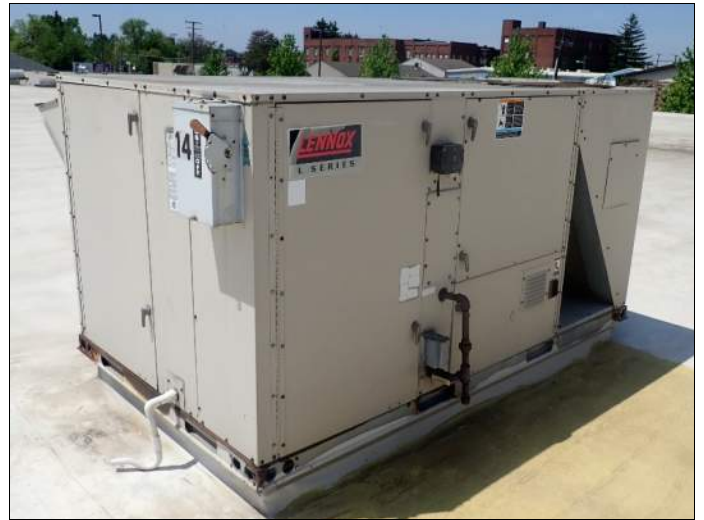
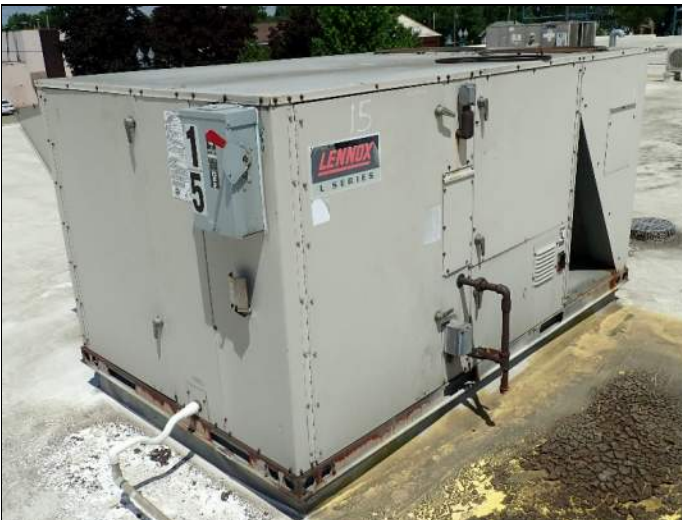
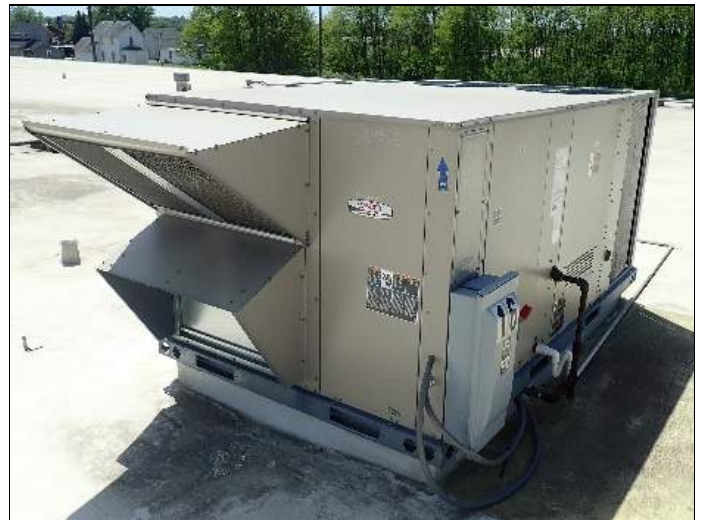
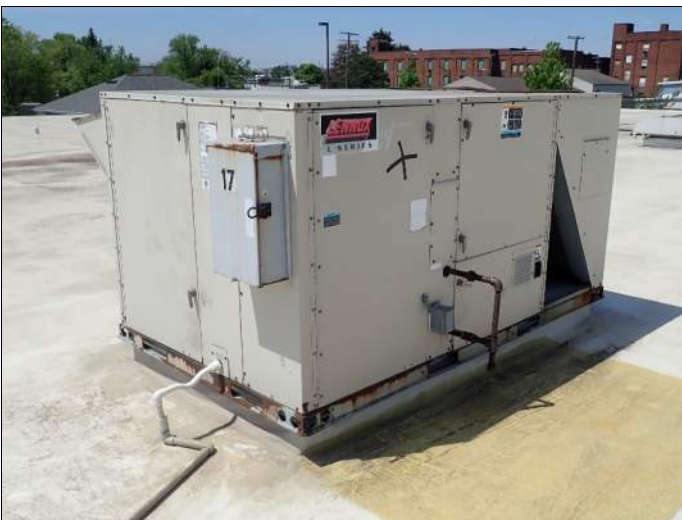
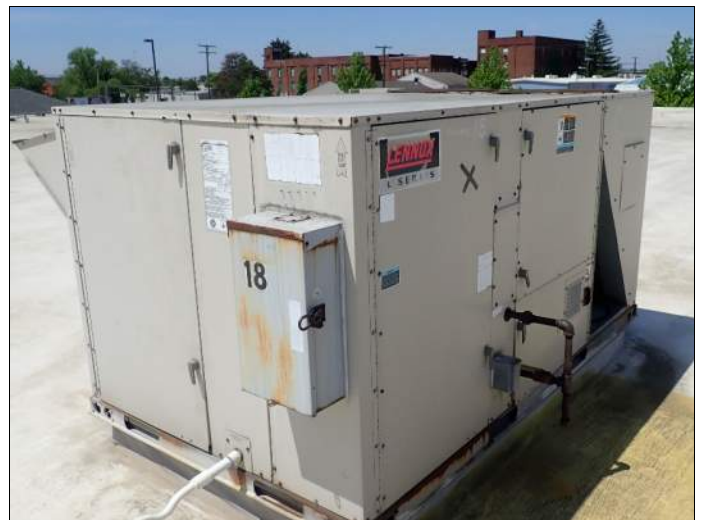
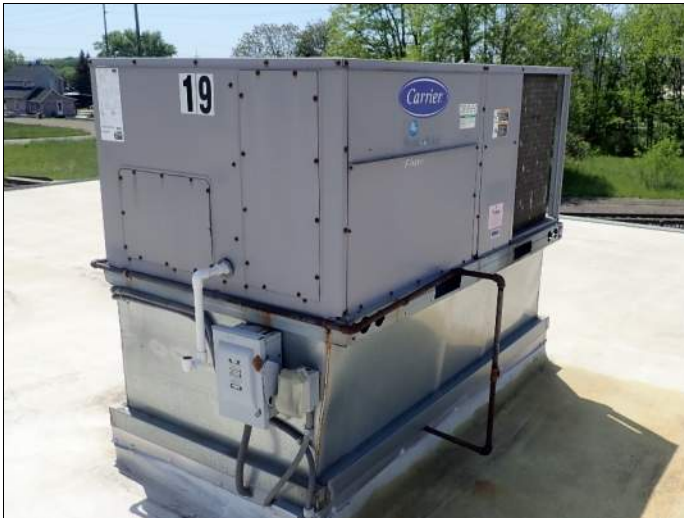
RTU have an average useful life of approximately 20 years. Seven of the units are 23 years old. The following RTU's have reached the end of their useful life and their replacement is recommended.

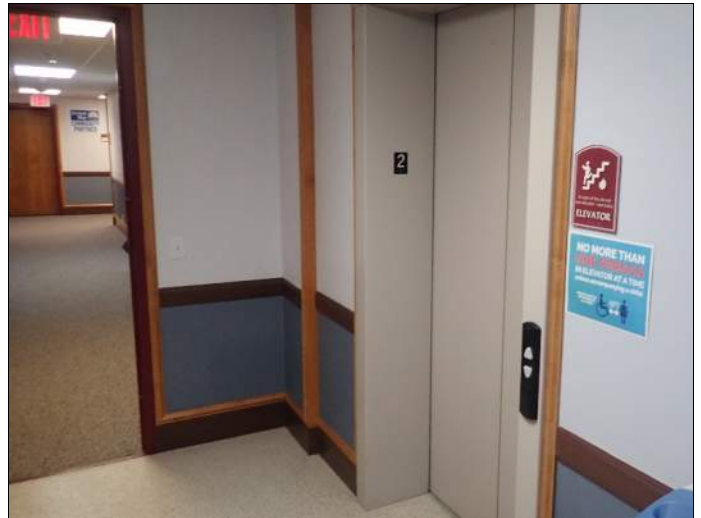
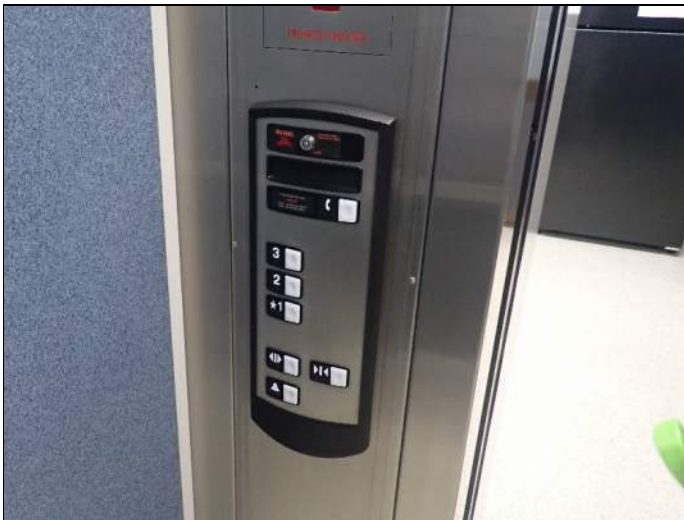
The elevator may not meet all ADA accessibility requirements for audible arrival and position indicators and emergency call controls. Conducting an ADA accessibility study of the elevator is recommended.

All elevator permits are current and posted inside the elevator car. Having the elevator equipment inspected on an annual basis is recommended.

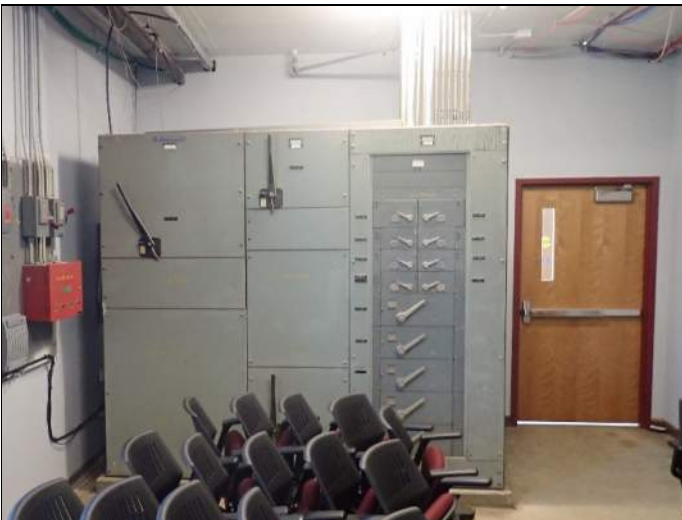
Overview of main distribution panel

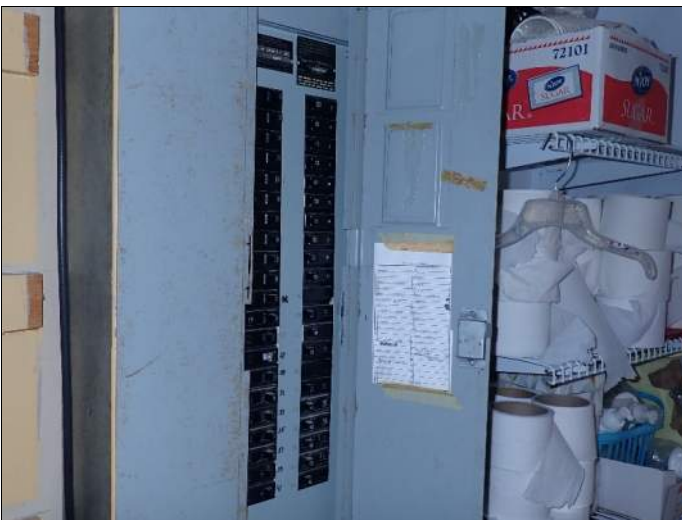
Typical subpanel

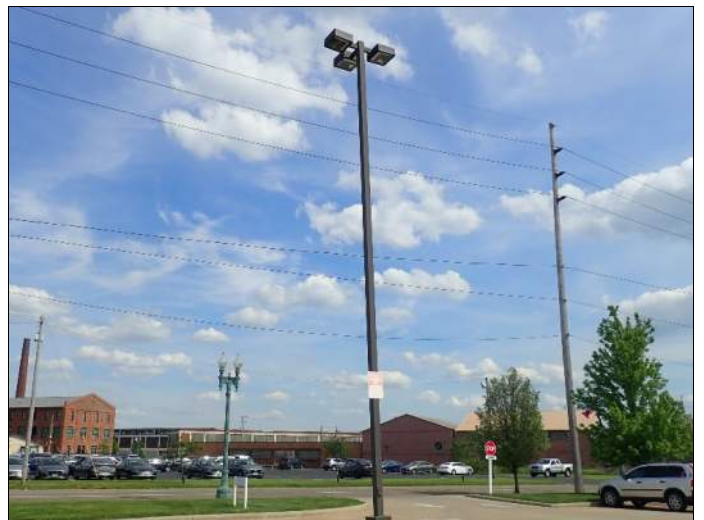
Typical pole-mounted lighting in parking area

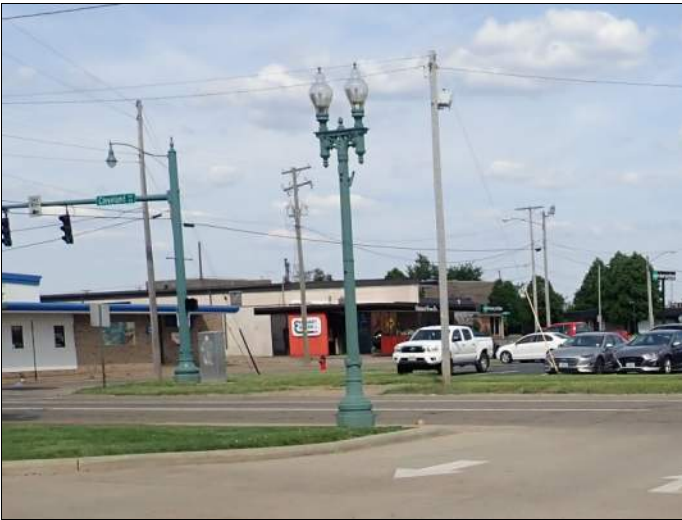
Typical municipal pole-mounted lighting

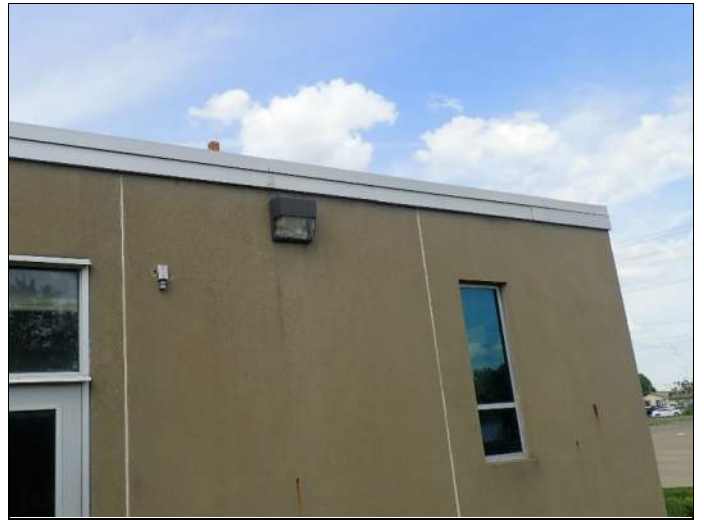
Typical wall-mounted lighting

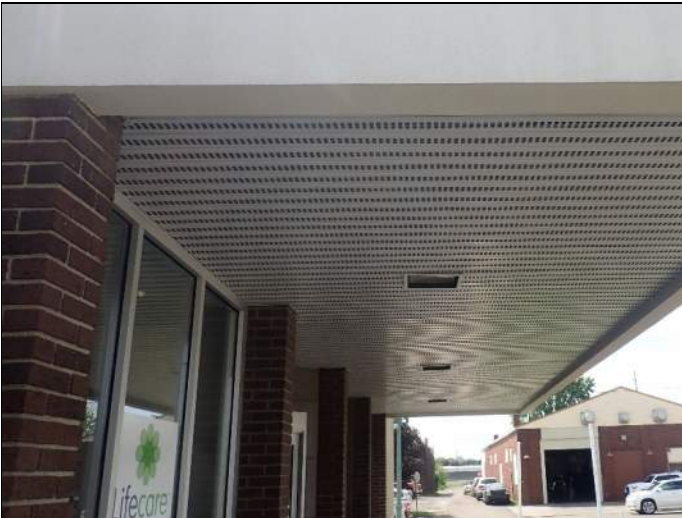
Outdoor recessed overhead lighting

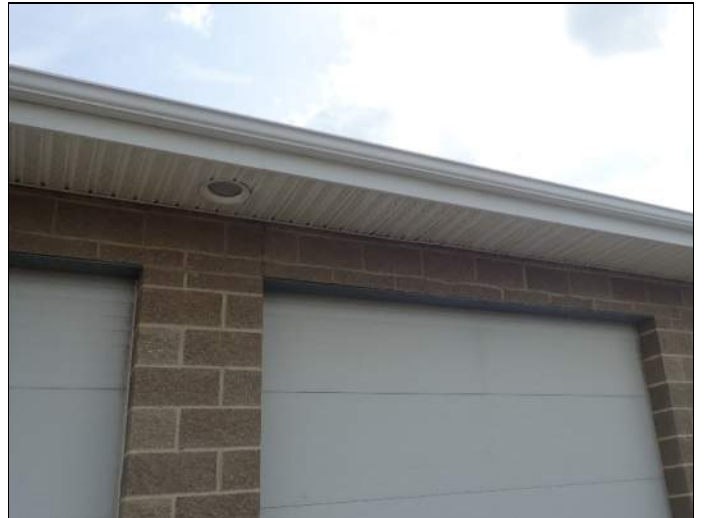
Outdoor recessed overhead lighting on garage

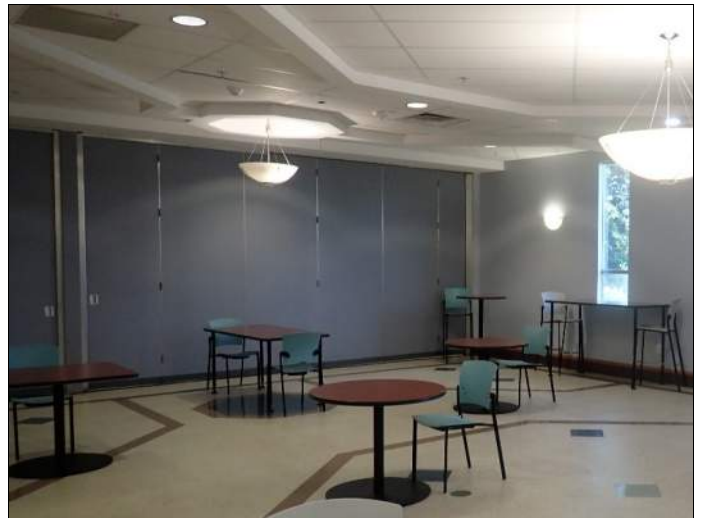
Wall-mounted, suspended, and recessed lighting

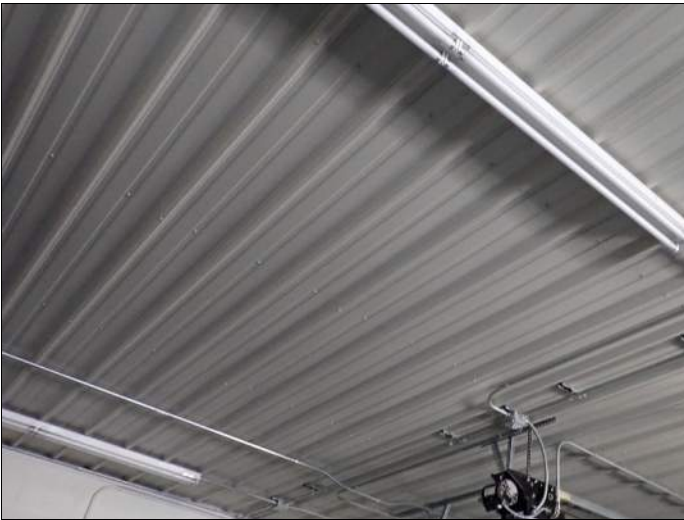
Typical interior garage lighting

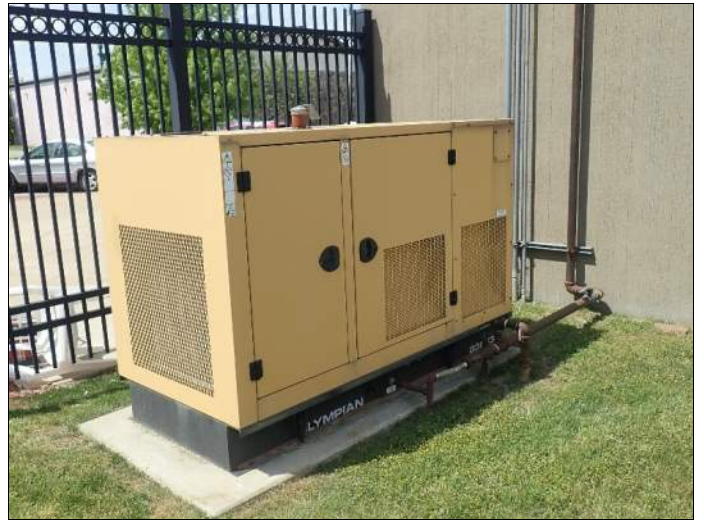
Overview of emergency generator

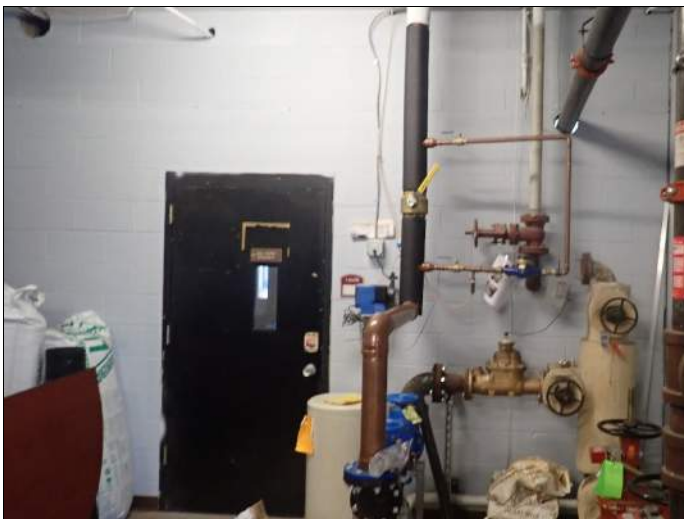
Overview of domestic water service

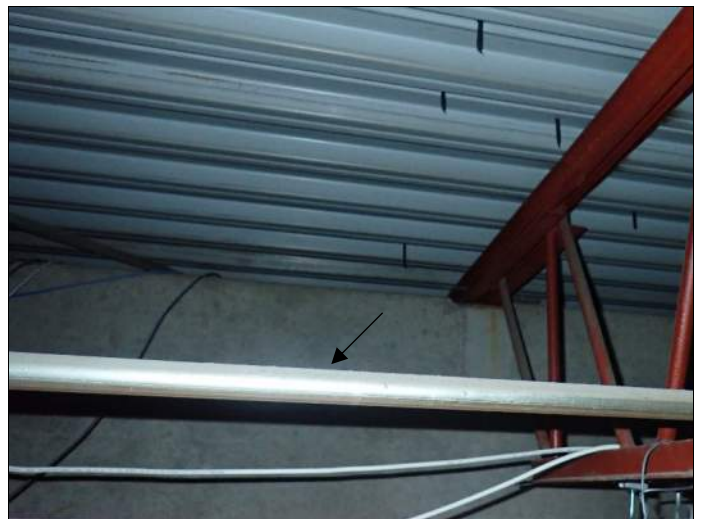
Typical water distribution tubing

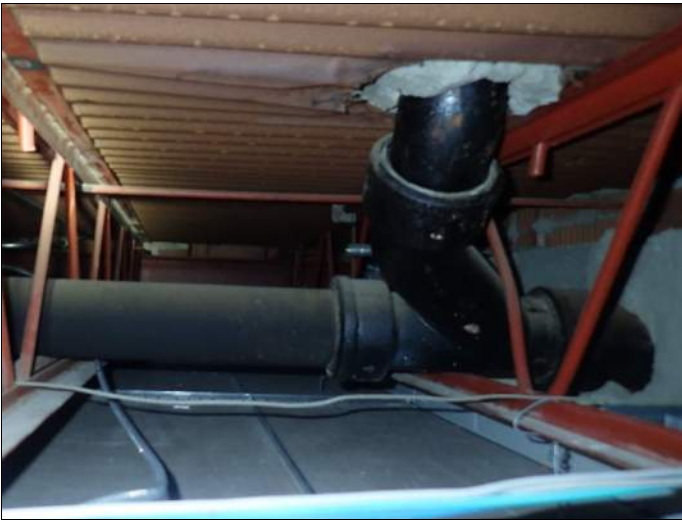
Typical sanitary waste tubing

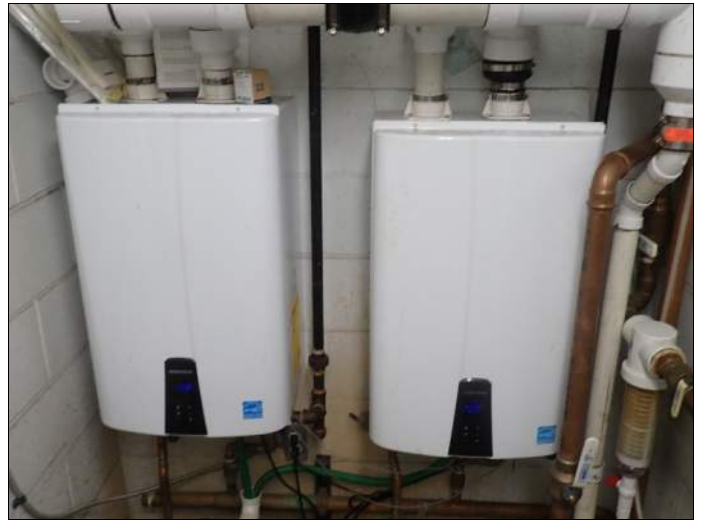
Overview of water heaters

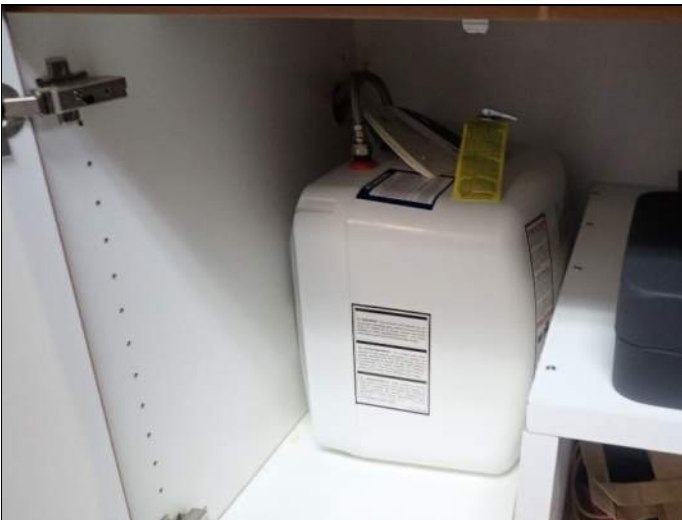
Water heater beneath sink

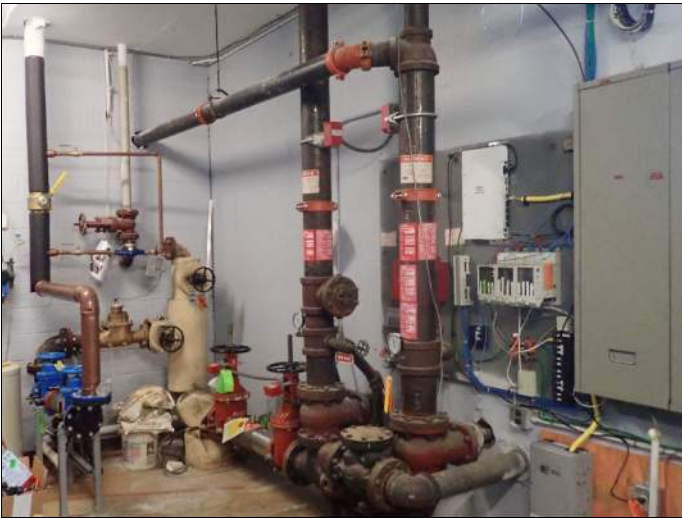
The sprinkler system was last serviced by RWJ Corporation in 2021. Fire riser pumps and sprinkler heads have average effective useful lives of approximately 25 years and 20 years, respectively. Continuing to have the sprinkler system serviced annually is recommended.

Fire sprinkler risers

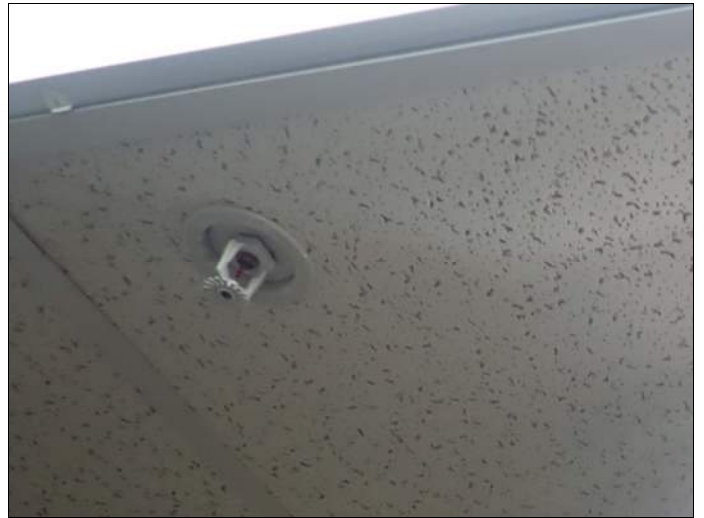
Typical sprinkler head

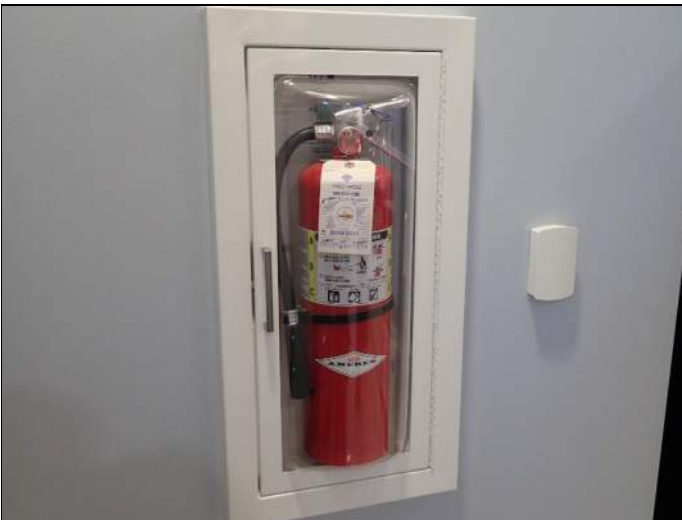
The fire extinguishers were last serviced by Protegis Fire & Safety in 2020. Continuing to have the canisters serviced annually is recommended.

Typical fire extinguisher

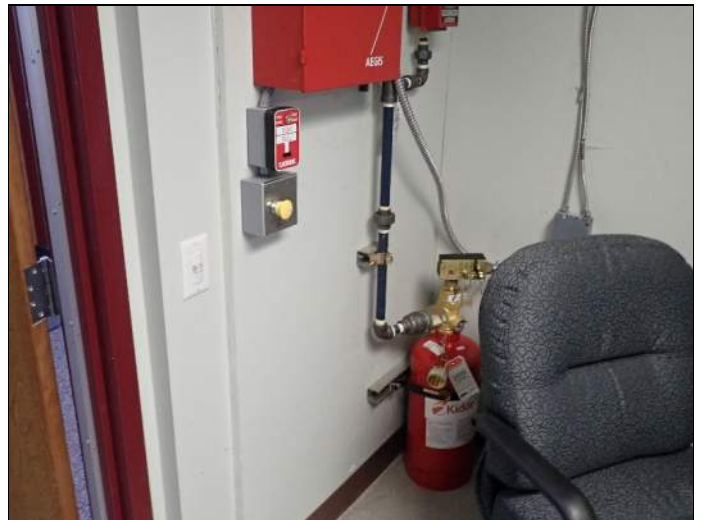
Server room fire suppression

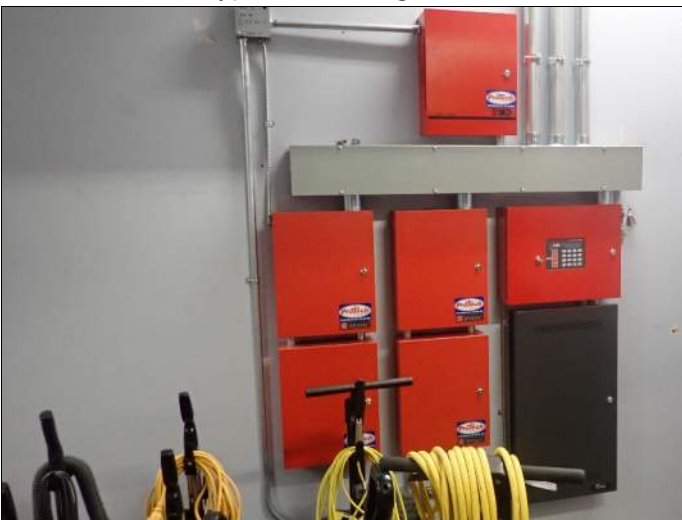
The average effective useful life for a fire alarm system is approximately 15 years. Having this system tested and maintenance performed annually is recommended.

Fire alarm system control panel

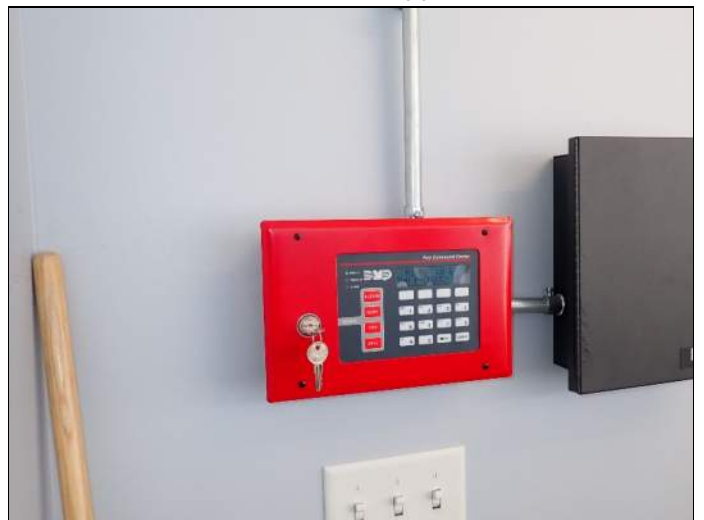
Fire alarm system secondary controls

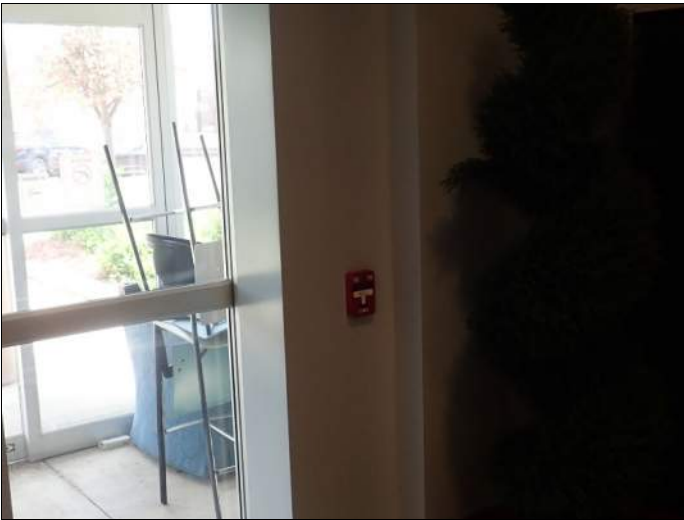
Typical fire alarm pull station

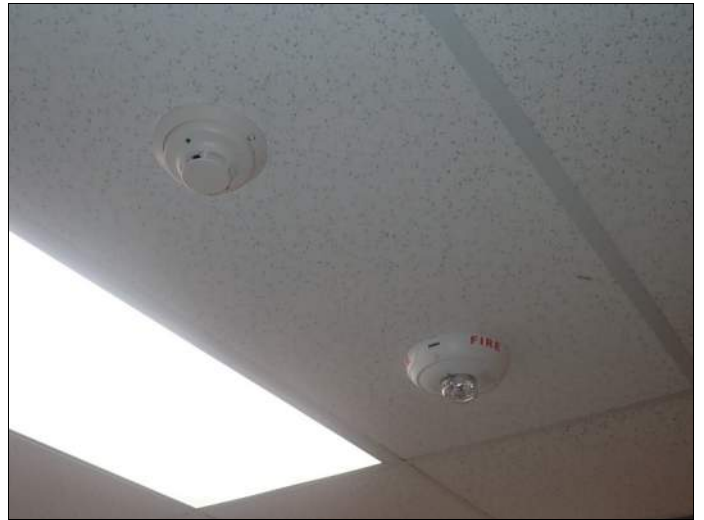
Typical audio visual alarm and smoke detector

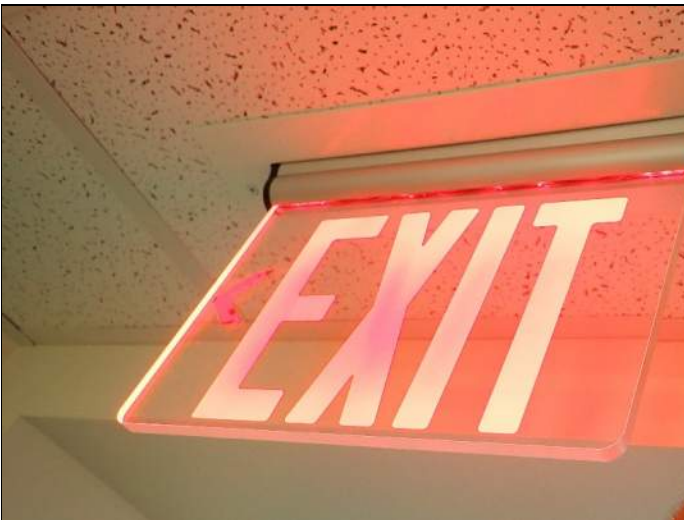
A sampling of the illuminated exit signs and emergency lights were tested and were found to be operational. Illuminated exit signs and emergency light fixtures have an average useful life of 20 years. Having these systems tested and maintenance performed annually is recommended.

Typical illuminated exit sign

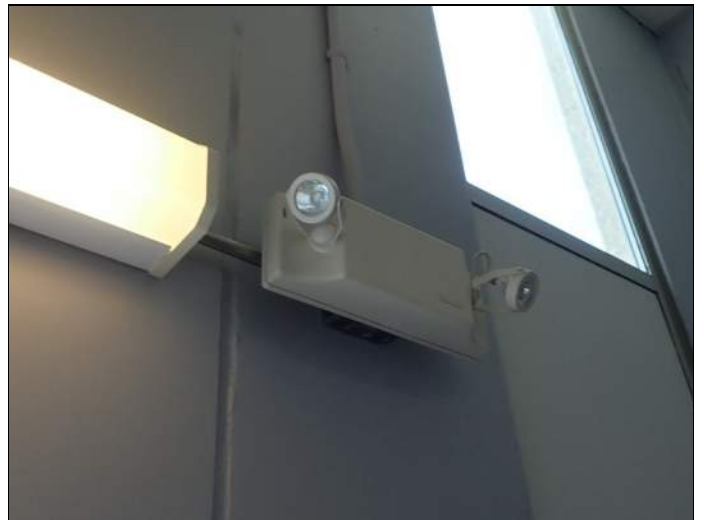
Typical emergency light fixture
